## Aviation Safety

# Maintainer

Issue 2/2003

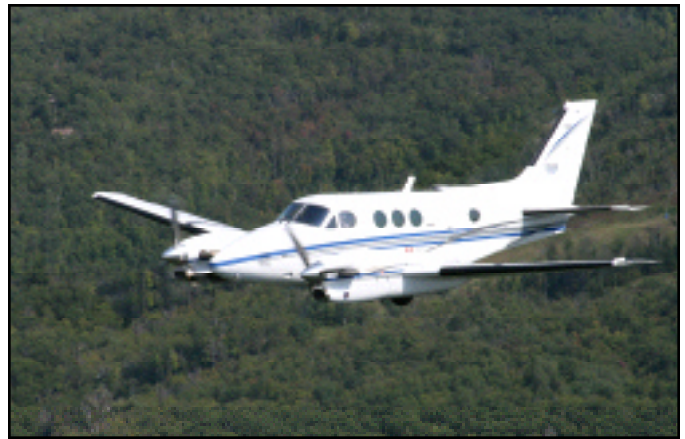
Photo courtesy of Transport Canada Aircraft Services, Training Centre  
Graphic Design MultiMedia Communications

What happened? The stabilizer trim actuator had detached itself from the fuselage structure allowing the stabilizer to move freely under the influence of air loads. Was it an isolated event? In the past four years there were two reports of similar events. In June of 1999, after the aircraft got airborne, it pitched up to approximately 70°, reaching a height of 500 to 700 ft. It then rolled to the left, pitched steeply nose-down, and descended to the ground within the confines of the airport. It

contacted the soft and flat surface in a relatively level attitude and covered a distance of 500 ft. It came to rest in a wooded area. Everyone onboard escaped injury. In both cases, it was found that during the installation of the stabilizer actuator, the two upper attachment bolts had been incorrectly installed forward of the actuator mounting lugs, inadvertently trapping the lugs between the shanks of the bolts and rivets in the airframe channel structure. A double check confirmed the installation of the bolt, washer and nut assemblies but the

proximity to the rear bulkhead, and the position of the trim actuator and channels made inspection with the use of a mirror difficult. The non-conforming installation was not detected. Under flight air loads, the (2) actuator lugs disconnected themselves from their anchoring points and left the pilots with uncontrollable horizontal stabilizer functions.

Complacency? Possibly! Always be diligent about dual inspections! 📌

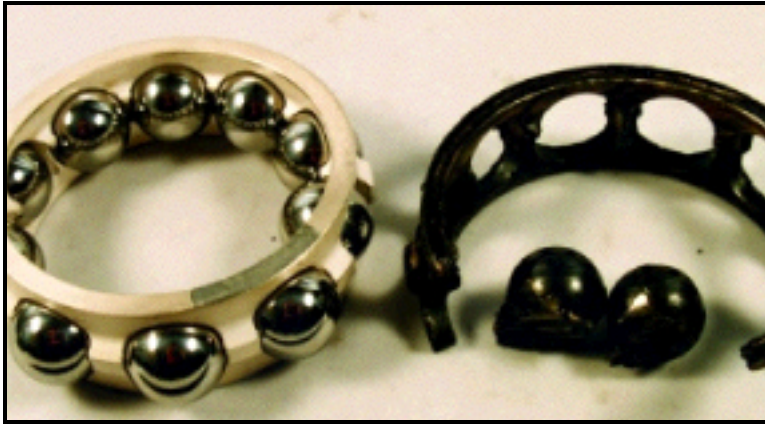
Comparison of a new bearing (left) with a bearing that has suffered from electrical discharge damage (right).

PT6A-60 engine operators should be aware of possible in-flight engine shutdown following accessory gearbox bearing failure. An Australian Airline, operating Short 360s, experienced four engine shutdowns over the course of 13 months. The Civil Aviation Authority of Australia (CASA) investigated the occurrences and found that operators overseas had experienced similar difficulties. The premature failure seems to be caused by an electric current discharge along the output shaft of the starter generator unit into the engine accessory drive train. The bearing and gears become pitted; as there is an electron flow transfer that takes place between bearing surfaces, races and in the gear drive system. The failure becomes imminent as soon as a threshold of wear is reached. High vibrations and imbalance of the assembly create overload. There is spalling and overheating, followed by the failure.

The study found that two types of starter generator armature defects could be the cause. The first case, which is the most common and preventable, is armature leakage due to the accumulation of brush dust. This build up of carbon dust will provide a path for electron flow between the commutator and the output shaft that will end as it reaches the

gearbox and a grounding plane. The second case is when a short occurs because of an insulation breakdown in the commutator or lamination slots. Periodic field cleaning and resistance check detailed in the Lucas maintenance manual is a simple and effective response to both of these serious problems.

Examination of failed engines revealed a complete breakdown of the number one bearing that lead to an engine failure. The manufacturer, TRW Lucas, is developing a new starter generator shaft that will insulate the armature from the engine drive gear. This modification will be directly interchangeable with existing installations.

Pratt and Whitney Canada has issued a series of SBs that require oil system monitoring of engines identified as being at risk and is studying a proposal to develop a modification that will insulate the engine gear train from electrical discharge. Raytheon has issued a Safety Communiqué for B1900D operators recommending that those who have had a starter generator removed for reasons other than scheduled maintenance, comply with the Pratt and Whitney SB, detailing the oil filter patch check inspection. It has also amended the maintenance manual to include starter generator output shaft spline inspection. B300 and B1900/B1900C maintenance manuals are also being revised.

Pilatus has reviewed the potential for electric discharge and has amended the maintenance manual to require the periodic cleaning of brush dust from the starter generator. The potential for electrical discharge is at its maximum when the accumulation of brush dust is large and there is a corrosive environment present. Elimination of such factors and scheduled inspection should prevent this type of engine failure. 🛠️

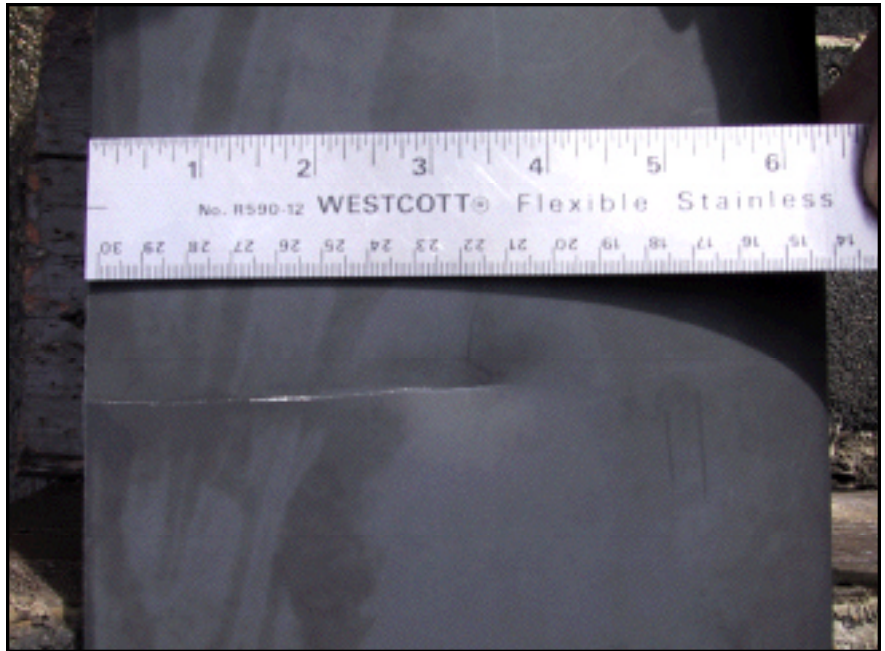
Two days prior to the incident, the McDonnell Douglas MD369D had been subjected to a 300-hr inspection and nothing was amiss. However, during the occurrence flight an abnormal vibration was felt and the pilot immediately noticed that the main-rotor blade was out of its track by six inches. He proceeded with the utmost caution and landed immediately. The helicopter was based on the coast of British Columbia and usually stationed on a floating barge where it was often subjected to high winds and bad weather. One day prior to the flight, the maintenance crew had removed the main-rotor blades because of high prevailing winds. On the day of the occurrence, they had reinstalled and secured the blades to prevent flapping. Following the mishap, the maintenance crew inspected the blades and found that one of them had four-inch cracks at the upper and lower skins extending from the trailing edge to the spar.

Torque events had not been recorded accurately on this helicopter during the first 2 000 hr in service; however, the current owner has been keeping track of them for the past two years. The blades had a recorded time in service of only 2 266 hr but the torque event cycle was estimated at close to 32 523 cycles. Examination of the blade using X-rays, electron and optical microscopes revealed a fatigue crack that had started from a nick or a rough radius on the edge of a lightening hole on the C-channel structure of the blade, about three inches inboard of the data plate. The fracture propagated to the top and bottom skins and subsequently across the chord of the blade, causing a separation at the trailing edge. The fracture stopped at or near the D spar structure near the leading edge of the blade.

McDonnell Douglas calculated that the blades had probably been subjected to operations and to torque events that likely exceeded the design limits. The manufacturer has since issued a

SB 369D-201R1 that should ensure the operator optimal helicopter dispatch while at the same time maintaining the highest level of safety. To quote McDonnell Douglas: “This bulletin references criteria to assist operators in understanding their level of usage, the impact of the usage on the main-rotor blade life and the corresponding inspections required to locate cracks that might occur.” In this incident, the recent inspection failed to reveal the crack. This leads us to believe that it can develop very quickly and with disastrous results. Since the manufacturer has not yet established a torque event maximum life cycle retirement phase, and because the complete failure of a blade is likely to lead to a tragedy, strict adherence to the McDonnell Douglas Helicopter SB is mandatory. As the picture shows, the crack stopped at the spar location. How long would the spar have held under heavy load? That’s the question! The helicopter was lightly loaded on this flight and the pilot took immediate action, which saved the day. Recording torque events and compliance with this SB is a must! Keep up the good work. 🛠️

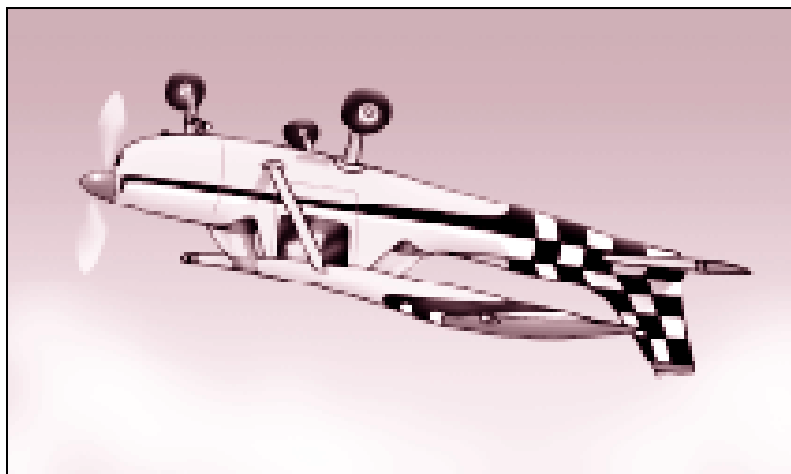
Following a close examination of the aircraft and the controls by an AME, the cause of the incident was located. It was an upholstery screw lodged in the aileron control chain on the control column that had jammed in the control wheel mechanism. Further inspection revealed that several upholstery screws were missing from upholstery trims and interior panels. The screws had probably fallen out of enlarged screw holes caused by the repeated removing and reinstalling of the aircraft's interior upholstery panels and by the vibration and flexion of the fuselage structure

created as the aircraft moved through the air. FOD can be deadly. It can easily create a hazard that will render an aircraft or system un-airworthy at the most awkward moment and possibly create a situation that will endanger human life. It takes a little hard work, diligence, professionalism and the belief in a job well done to eradicate this menace. This tragedy was averted through sheer luck and a strong will to survive. Be proud to say that your aircraft are always free of FOD. 📧
